WELDING INSPECTION REPORT

Resident Engineer: Pursell, Gary **Report No:** WIR-004933 Address: 333 Burma Road **Date Inspected:** 12-Dec-2008

OSM Arrival Time: 630 **Project Name:** SAS Superstructure **OSM Departure Time:** 1530 **Prime Contractor:** American Bridge/Fluor Enterprises, a JV

34-0006 **Bridge No: Component:** OBG

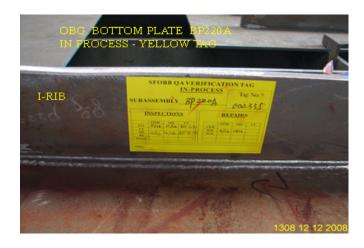
The QA Inspector randomly observed ZPMC NDT Technician Xu Hai, utilizing the Magnetic Particle Testing (MT) Method to perform a final 100% MT examination on the cover pass of the fillet welds on Deck Plates DP533A Yellow Tag 002334 (SP533-001); DP532A Yellow Tag 002333 (DP532-001); a 10% MT examination on the cover pass of the fillet welds on Side Plates SP224A Yellow Tag 002337 (SP224-001) and SP225A Yellow Tag 002338 (SP225-001); Bottom Plates BP220A Yellow Tag 002453 (BP220-001) and BP221A Yellow Tag 002451 (BP221-001). There appeared to be no indications and ZPMC QC accepted all the welds on the above listed panels. The attached photograph provides additional detail.

The QA Inspector performed a 100% final Visual Testing (VT) and 10% MT verification on the cover pass of the fillet welds on Deck Plates DP532A Yellow Tag 002333/Green Tag 002449 (DP532-001), DP533A Yellow Tag 002334/Green Tag 002450 (DP533-001), Side Plates SP224A Yellow Tag 002337/Green Tag 002448 (SP224-001) and SP225A Yellow Tag 002338/Green Tag 002452 (SP225-001); Bottom Plates BP220A Yellow Tag 002335/Green Tag 002452 and BP221A Yellow Tag 002336/Green Tag 002451 (BP221-001). There appeared to be no indications and the QA Inspector accepted all the welds on the above listed panels.
